# Bicycle Parking Monitoring Pilot - Summary Report

WestTrans 2016

# Bicycle Parking Monitoring Report

Report on the inspection of 71 West London developments with a cycle parking requirement in accordance with the London Plan and the quality of cycle parking available at each site. Sites were judged against the West London Cycle Parking Standards. On the whole, nearly all sites failed. Many did not provide any cycle parking at all. This report assumes the reader has knowledge of the London Cycle Design Standards or the West London Cycle Parking Guidance.

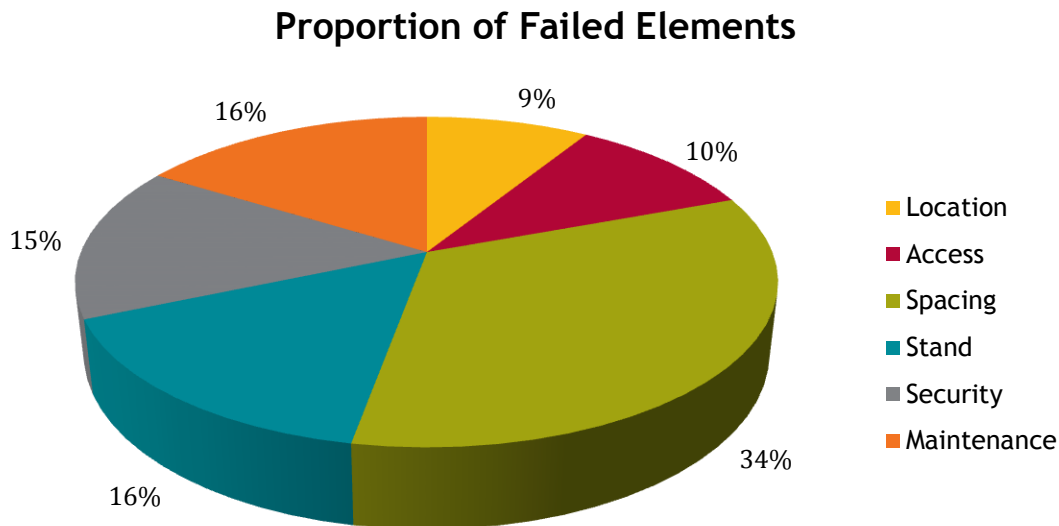
**Figure 2. Proportion of elements failed excluding no parking provision**

The above is a representation of the proportion of failed elements; the percentage of fails per element per cycle parking location is shown in table 4. Eg. 22 sites failed due to location issues.

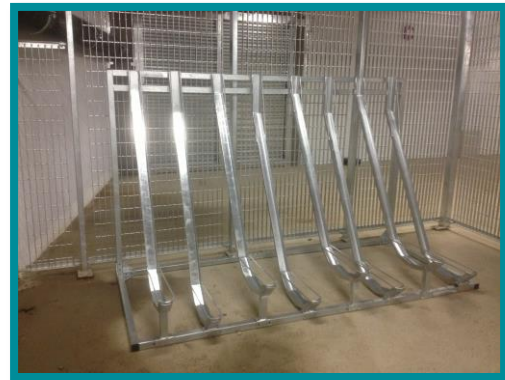
**Figure 3.**

Assuming all other cycle parking elements were satisfactory, 81% of sites would have failed on spacing. Many sites used prefabricated racks of either ramped or Sheffield stand design as shown in figure 3. None of the ramps conformed to the guidance for stand spacing; many were as close as 300mm stand centres (The distance between the centre of two stands or spaces). Guidance recommends 1 metre for Sheffield and 500mm for ramped stands.

Over a third of cycle parking locations failed on their choice of stand. Many sites used prefabricated racks with 300mm spacing as shown in figure 3 or installed individual Sheffield stands as close as 450mm centres.

Our inspectors, who tested each site with their own cycles, found that the ramped stands (figure 3) are too difficult to use unless the cyclist has good upper body strength or the bicycle is extremely light. When this type of rack was provided, the inspectors often counted bicycles secured to the sides of them as shown in figure 4.

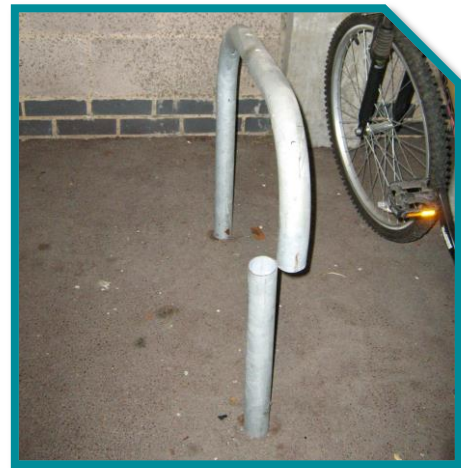
Figure 5.

Many sites did not offer secure areas for long term parking, that is, there was no extra protection given to bicycle security than that shared by the car users. Stands were located in the car park or where any site user could access. Evidence of bike theft within a closed basement parking area illustrated the need for a cycle-specific cage or room. In addition, cheap stands (inferior material construction) had been cut instead of the chain securing the cycle, figure 5.

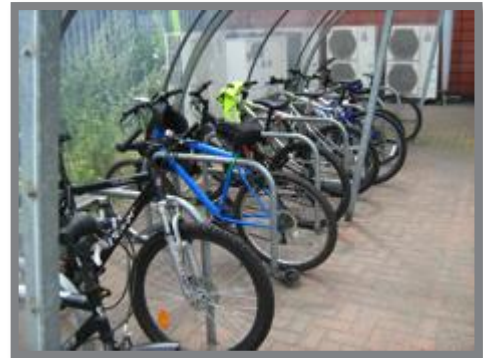
Figure 6.

This unit is located within a west London industrial estate which is gated and guarded. The cycle parking does not meet the specific requirements for long term parking for security reasons (no secure area) but the site operates within a secure estate with excellent CCTV. Stand spacing was 50mm less than recommended, however, because all other elements were excellent, the location was recorded as tolerable.

Element	Short & Long Term Location
Location	Pass
Access	Pass
Spacing	Tolerable
Stand	Pass
Security	Pass
Maintenance	Tolerable

This development provided a total of 46 cycle parking spaces of which 14 were occupied.

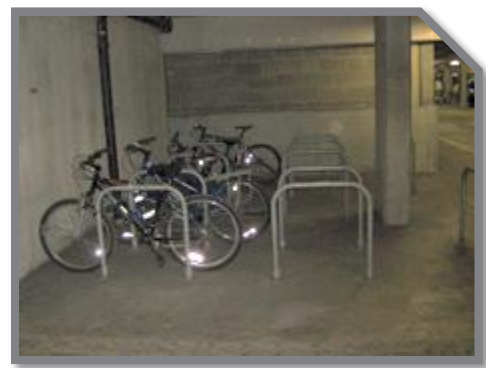
Figure 7.

H23 is a very large development (471 units and a hotel) with a double-storey parking area combining both car and cycle parking - this type of development requires a large number of cycle parking spaces. Although access, stands, spacing and the cycle parking location would meet the standards, the location of the stands among parked cars did not give a feeling of security. Additionally, the car park looked neglected in terms of maintenance, as did the cycle parking. Bikes were often dusty - to the point that some cyclists covered their bikes with motorbike covers.

Furthermore, considering the high number of spaces that had to be provided, the developer did not take into account the distance of each stand from the entrance and set out the cycle parking at increasing distances from the entrance. The result is that some stands were over 100 meters away, which caused the nearest stands to be overused (more cycles using a single stand than should), while those further away were not used at all. This example stresses the importance of planning cycle parking in large developments in separate storage clusters and not in the main car park as it presents a number of issues on maintenance, security and location.

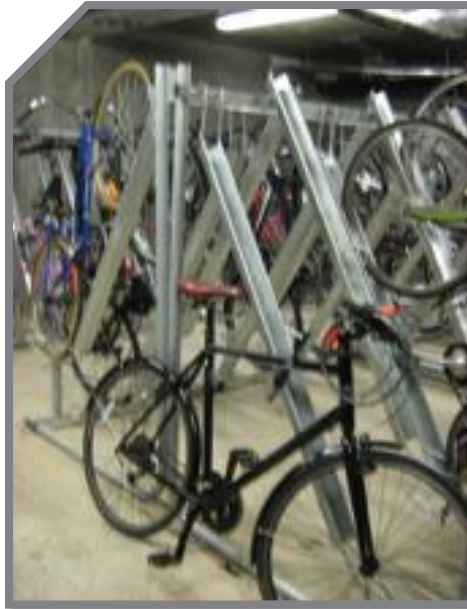
Figure 8.

This residential development comprises 131 residential units. The cycle parking is located in the underground car park, in a separate room. The size of the room is such that it was impossible to fit in enough Sheffield stands to fulfil the quantity requirement. The stands in the storage area are ramped stands (semi-vertical rail rack) at 300mm centres, with

aisle widths of 1.50m. This type of stand, although useful to accommodate a large number of parking spaces in a limited area, is very difficult to use and requires a lot of strength. Depending on the bike owned, it may be impossible to park it on this type of rack. Furthermore the inappropriate spacing makes it very difficult to manoeuvre a bicycle and can discourage residents from parking their bike. Some of the bikes in the storage area were therefore not locked up properly on the stands but just attached to the bottom of the rack’s frame. This example shows the importance of designing storage areas large enough to accommodate a sufficient number of cycle parking spaces of appropriate standard. Despite the poor choice of stand, difficult access and tight spacing, **37 of the 76 spaces were used**. This may probably be close to the **effective capacity**, with tight spacing making it difficult to use more than half the alleged capacity!

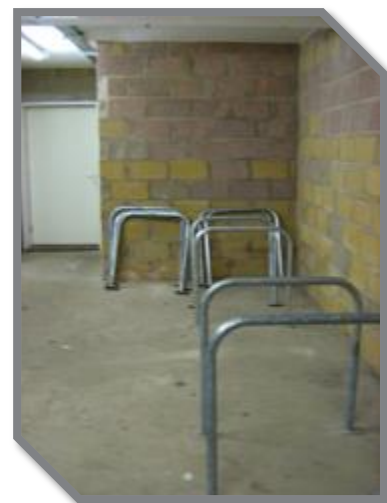
Figure 9.

The last important issues noticed in long term parking spaces were related to security and maintenance. In large residential developments, the maintenance of common spaces is often complicated. As the cycle parking is used on a daily basis, it’s inevitable that doors, lighting and stands will need repair. If there is no external contractor - or no one reporting the maintenance issues to the site manager, people will feel unsafe in the cycle parking areas; the ‘broken window theory’ perpetuates the feeling of abandonment leading to further deterioration. During visits, it was common to see CCTV signage without CCTV, stands that were cut in half or even dead bikes on stands. Unlike in a workplace, where people know the hierarchy and the manager of the site, on residential

developments (when there is no concierge) the person responsible for managing the cycle parking is often unknown to the residents. This situation highlights the importance of communication with the residents on security and maintenance to avoid bike theft and the feeling of insecurity.

Residential Building E8 is a recent development where the cycle parking is located in a separate storage room close to the residents' entrance. However, the door does not lock and stands have been removed from the floor or are still awaiting installation. The location does not appear suitable to park bicycles as there's graffiti on the walls and dead bikes on the remaining stands. Residents do not use the parking area and bikes are parked on balconies or in the alley. It's unclear if the poor access (three sets of heavy doors) or lack of maintenance has caused this area to become abandoned but it's self-evident from the effort residents have made to store their cycles as safely as possible that many wish to cycle.

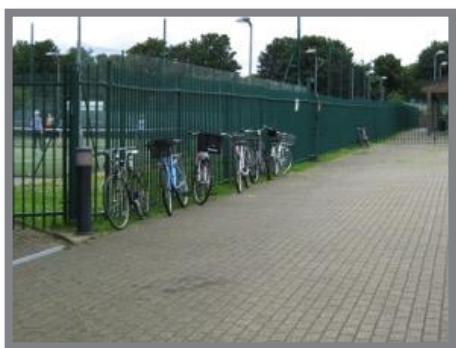
Figure 10.

The pictures show that only half of the cycle parking provided is used (figure 11.) because the other half is too far from the building entrance, on a remote side not covered by CCTV and too close to a car wash. That leads visitors to choose the alternative of parking their bikes right next to the entrance on lampposts or

fences (figure 10.) while much of the cycle parking is still empty. This is a common issue, especially with short term parking

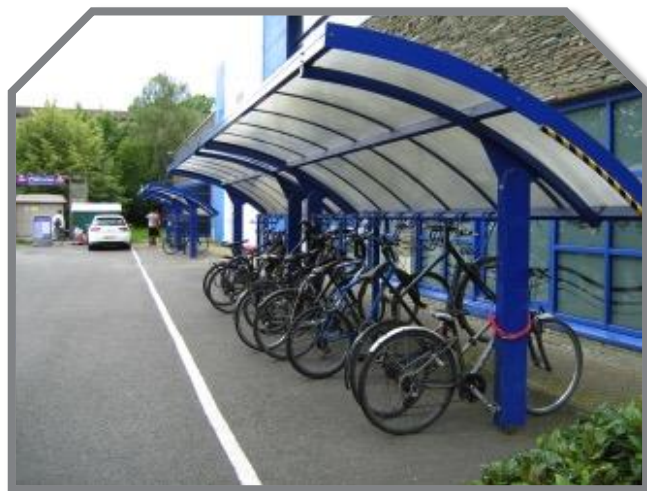
Figure 11.

42 spaces provided, 10 used.
